STS-114: Engine Cut-Off Sensors Are a No-Go

Launch Rationale

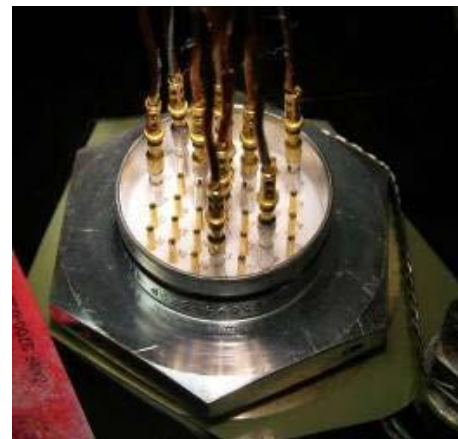
Several launch attempts in which the anomalies were repeated led to successful detection of the problem area. As Robert Kichak points out, “Ultimately the cause of the problems was conclusively determined to be in the external tank cryogenic feed-through connector. We were finally fortunate enough to have the problem occur and persist with the extra instrumentation in place to determine exactly where it was happening,” [2]. Due to the use of time domain reflectometry (TDR) installed during a December 2007 tanking test, the team was capable of pinpointing an open circuit should it recur. ECO-2 and ECO-3 exhibited erratic behavior during testing while ECO-1 failed wet about 25-30 minutes after sensors were initially wetted. An open circuit was indicated somewhere outside of the PSB according to the ECO voltages. TDR equipment was then plugged into staged break points and the open circuits were isolated to the area of the feed-through connector [4]. Open circuits in the feed-through plate, the part that connects wires from the interior to the exterior of the liquid hydrogen tank, were identified as the culprit causing false readings during launch

Fig. 2: Soldered pins/sockets [4].

attempts and tanking tests. Modifications were made to solder the external harness sockets and the feed-through pins of these connectors together. Once subjected to temperature, pressure, and vibration environments identical to those experienced during a Shuttle launch, the new configuration was verified as adequate and led to successful performance thereafter.

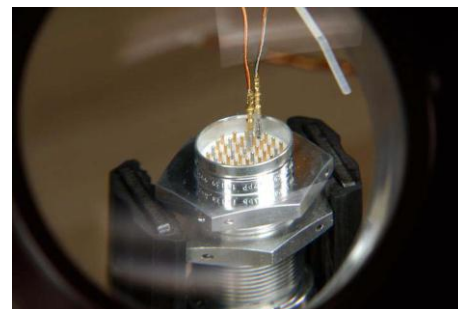
Fig. 3: Modified feed-through connector [6].
